Lake Lemon Diagnostic/Feasibility Study

Environmental Systems Application Center
School of Public and Environmental Affairs
Bloomington, Indiana

April 1986

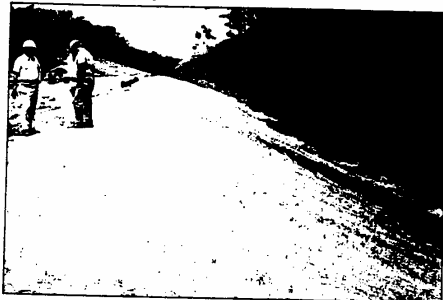
Vegetation growing through the curlex matting helps anchor the mat in place, with each blade of grass becoming another anchor point.

Slope Applications

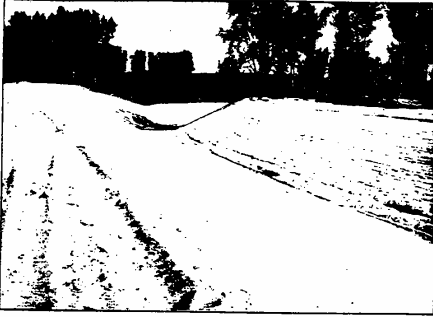
Ditch Lining Applications

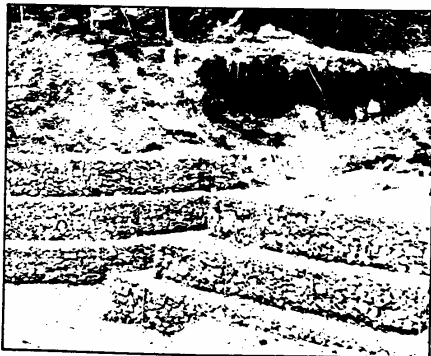
Fig. No. 9

The exposed face(s) should be hand-placed using selected stone. This hand-placing will add to the appearance of the structure by preventing the gabions from bulging. (See Figs. No. 9 & 10).

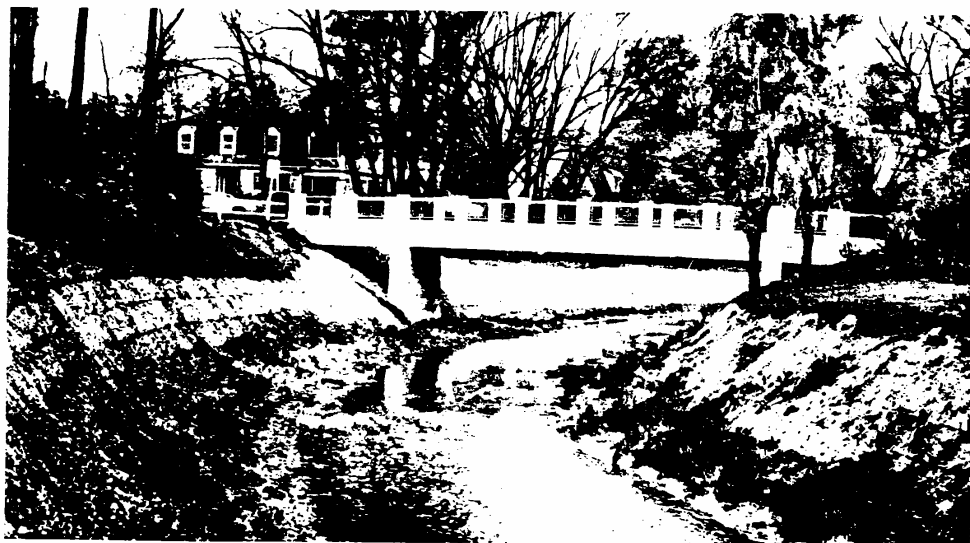
Fig. 20—18" gabion revetment provides an effective and economical protection for the bridge.
